# PROJECT PROFILE

**PROJECT:**  
Kearns Building  
Salt Lake City

**OWNER:**  
Hines  
Salt Lake City

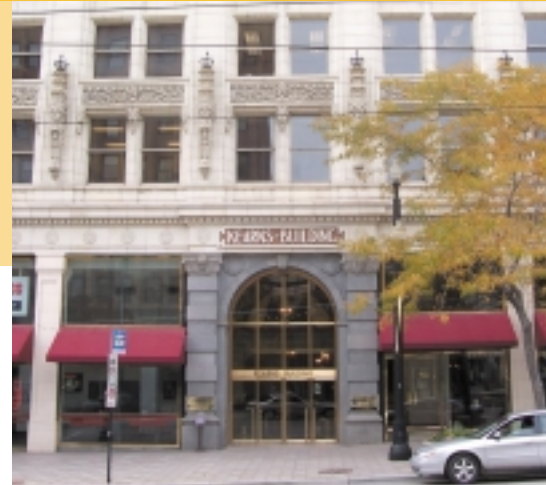
**TOP:** Kearns building. **CENTER:** Window frame and mortar joints being repaired. **BOTTOM:** Looking down on CRS swing stage.

CRS mechanically removed the decayed wood and used an epoxy filler to restore the wood to its original shape and dimensions. The repaired wood was repainted and the cracked glazing putty was repaired with a high-quality sealant. The deteriorated mortar was removed and replaced with new mortar. CRS's crew utilized a swing stage to complete the work and maintained access to the building throughout the duration of the project.

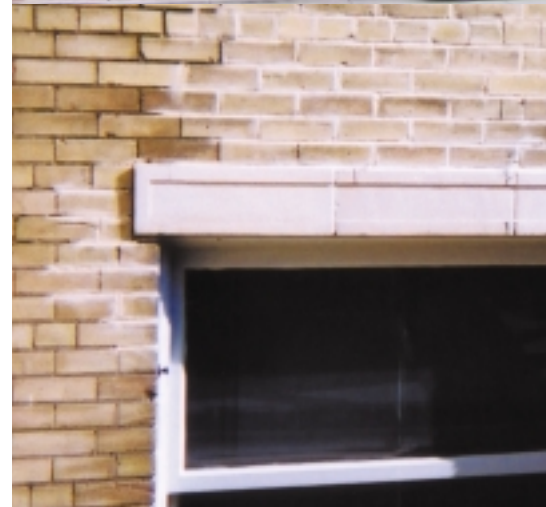
The building's wooden window frames and sashes had areas of decay, and the bricks and mortar were showing signs of deterioration and water intrusion.
