PROJECT PROFILE

PROJECT:
Tenth Ward Planters
Salt Lake City

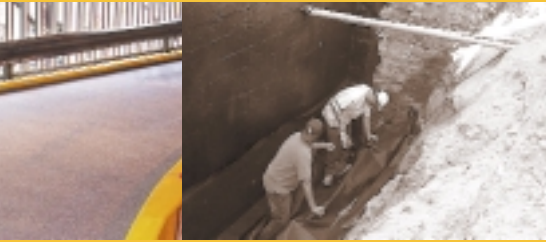
The planters were leaking water, which was causing freeze-thaw damage to the sandstone exterior.

TOP: Freeze-thaw damaged sandstone blocks (note sandstone fragments in foreground). CENTER: Waterproofed planter being back-filled. BOTTOM: Finished project.

CRS excavated the planters, cleaned the walls, and installed a high-quality membrane and protection board. The sprinkler system was then reinstalled, the planters were back-filled, and the original plants were replanted. CRS maintained access to the Tenth Ward building for the duration of the project.
