PROJECT PROFILE

Park Side Tower
Salt Lake City

Fall of 2004

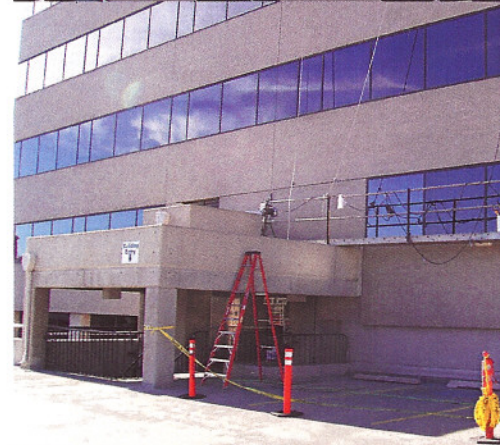
TOP RIGHT: Park Side Tower. CENTER: Swing stage used for inspection and repairs. BOTTOM: Completed repairs.

CRS installed a swing stage on the exterior of the building and used low-pressure water to test the walls and windows to determine where the water was entering. Upon discovery, the unfilled cracks and voids were filled with a urethane caulking to stop the water intrusion.
