# PROJECT PROFILE

Embassy Suites  
Salt Lake City

Fall of 2005

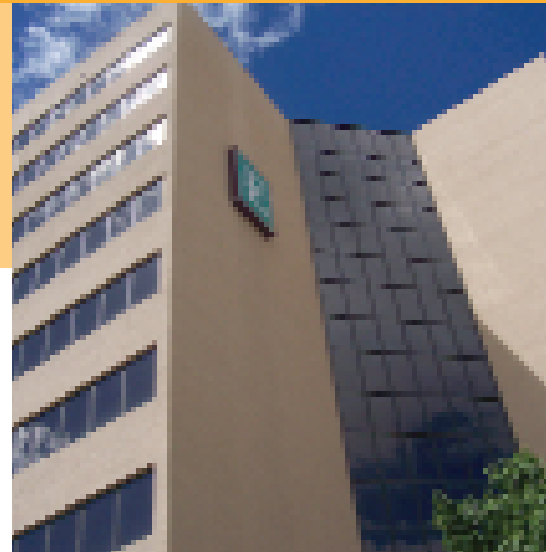
The facility's parking structure had problems with ponding water on the bottom, middle and top levels. Additionally, many of the structure's pre-cast tee corbels were severally water damaged. Finally, due to water damage and thermal movement, the concrete deck-topping and caulking were deteriorated and in need of repair.

**TOP:** Embassy Suites Tower. **CENTER:** Corbel under repair. **BOTTOM:** Completed project.

CRS water tested the structure to determine the correct placement for new deck drains. After CRS installed the drains, the structure was water tested again to ensure that the structure was draining properly. Once the water problem was solved, CRS removed the deteriorated concrete from the corbels, mechanically cleaned and epoxy coated the steel, and installed new concrete. To complete the project, CRS installed an expansion joint on the top level, repaired the deteriorated concrete deck topping and caulking, and installed a waterproof traffic membrane.
