WHAT HAPPENS WHEN A RESTORATION PROJECT FAILS?

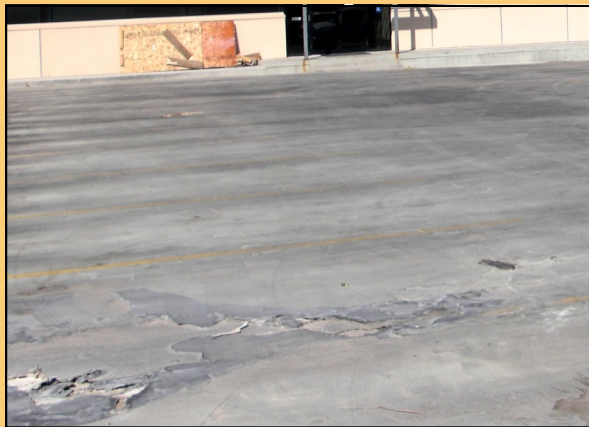
1.) When waterproof coatings are not applied properly to parking structure surfaces the materials begin to peel away leaving the concrete vulnerable to degradation.

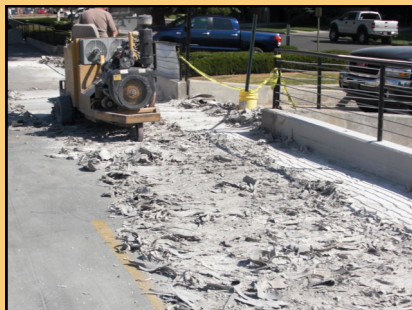
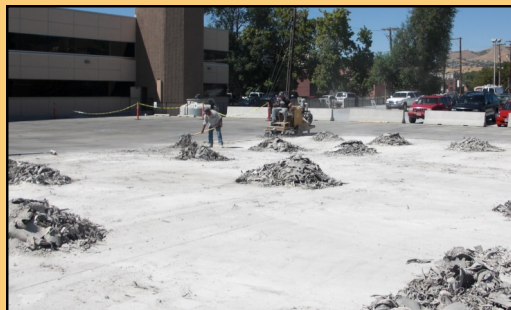
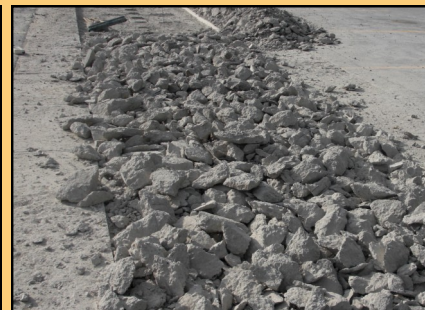
3.) The correct recourse to mitigate this type of destruction is to mechanically remove the coating, remove spalled concrete, repair reinforcing steel and post tension cables, replace the concrete, route and caulk control joints, and properly re-install a waterproof membrane system.
