PROJECT PROFILE

BROADWAY BUILDING PARKING STRUCTURE ENTRANCE REPAIR
Salt Lake City, Utah

HAMILTON PARTNERS
Salt Lake City, Utah

FALL OF 2008

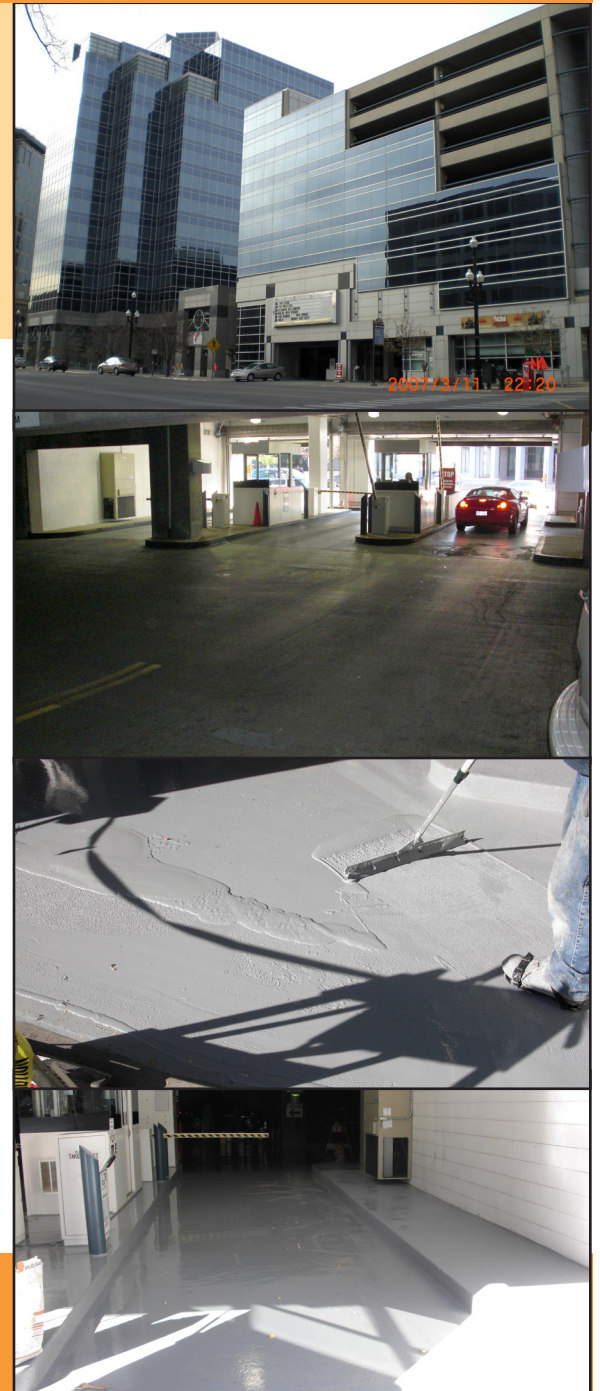
1. Entrance to parking structure at the Broadway Building
2. Existing coating at the ticket booth
3. Application of coating
4. Completed waterproof membrane system

The existing surface coating on the concrete was showing signs of wear. Adhesion tests were performed to insure the new coating would bond with the pre-existing surface coat. A new traffic bearing waterproof membrane system was installed at the entrance and exit of the parking structure. This was accomplished using a "Fast Cure" system over a period of 3 weekends which allowed the ticket booth to remain open at all times during the installation.
