# PROJECT PROFILE

Oakbrook Building Parking Terrace  
Salt Lake City

Reaveley and Associates  
Salt Lake City

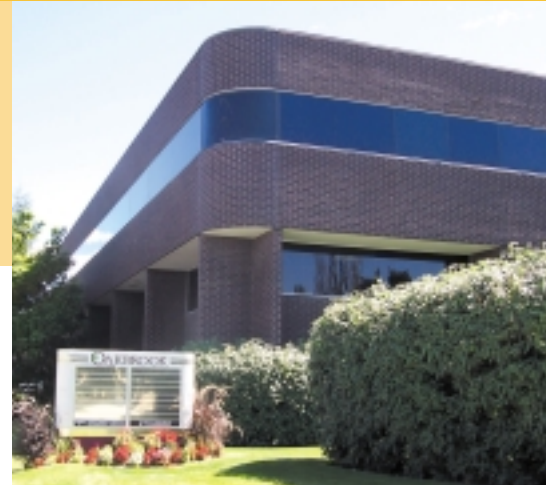
**TOP:** The Oakbrook Building. **CENTER:** Concrete repair in progress. **BOTTOM:** View of completed traffic coating.

CRS mechanically abraded the top-level parking areas and installed a urethane mortar to fill in surface spalls and imperfections. A urethane traffic coating was installed to the top level to protect the concrete from further deterioration. CRS also removed the spalled concrete from the column and from the stairs and replaced it with new material to match the original shape and dimensions. CRS maintained access to the lower-level parking areas and to the building for the duration of the project.
